CALIFORNIA DIVISION OF MINES AND GEOLOGY
Supplement^{#1} to Fault Evaluation Report FER-12

RE: Engineering Geologic Investigation of Potentially
Active Faults, Hollister Ranch, Santa Barbara County,
California

Soil/Geomorphic Observations, December 22, 1977
South Branch, Santa Ynez Fault

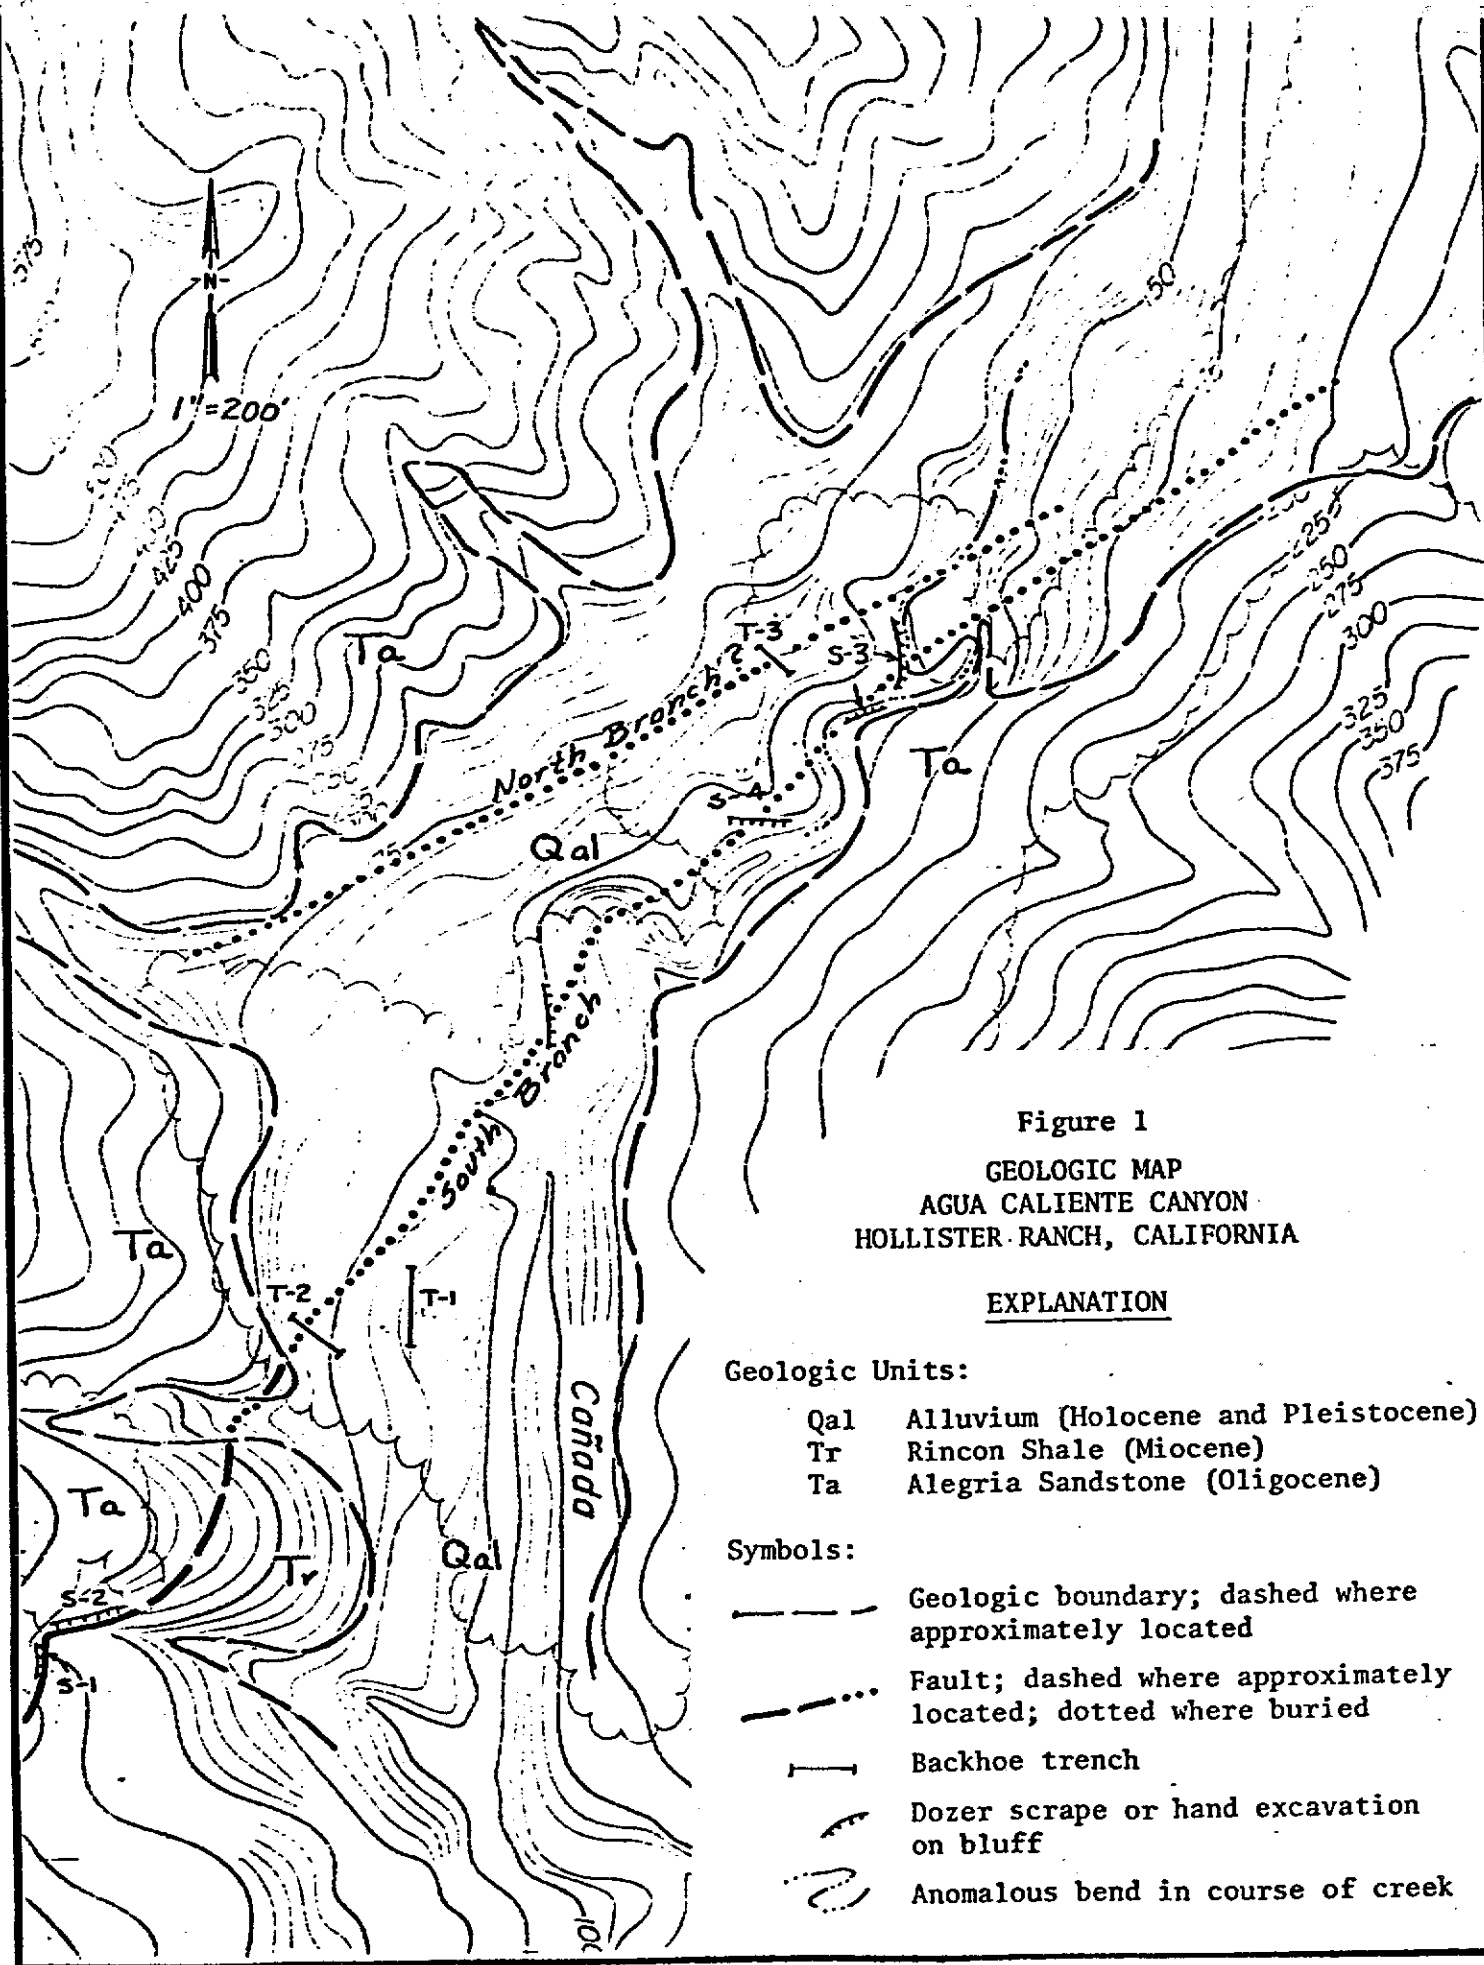
Figure 1
GEOLOGIC MAP
AGUA CALIENTE CANYON
HOLLISTER RANCH, CALIFORNIA

Existing cuts along the dirt road in the southwestern part of the area (S-1 and S-2 on Figure 1) were further excavated to obtain fresh exposures of the fault in both bedrock and the overlying slope wash (colluvium). The following relationships were observed at these two localities:

- a. The fault trends generally north 30° east and is inclined to the north at approximately $50-60^{\circ}$. Locally, however, the inclination of the fault plane is much lower, and is near-flat in parts of the exposure at S-2.
- b. The fault exposes Alegria sandstone over Rincon shale indicating apparent reverse or left-lateral movement. Poorly developed striations in the clay on the fault plan indicate the most recent movement to be primarily reverse with the northwest side up (i.e., Alegria thrust over Rincon).
- c. The fault does not cut the slope wash, the age of which is unknown.

Three backhoe trenches (T-1, T-2, T-3) were excavated in the upper terrace surface along the projected trend of the fault. Two of the trenches were located across topographic features, the alignment and character of which suggested possible fault scarps. While bedding was poorly developed to non-existent in the upper terrace deposits, relationships were sufficiently developed to establish that the surficial features are not fault scarps. Other than this, there was no evidence of faulting of the upper terrace, but on the other hand, faulting cannot be precluded because of the poorly developed bedding and homogeneous nature of these deposits.

Two dozer scrapes (S-3 and S-4 on Figure 1) were excavated in the lower terrace deposits along the expected trend of the fault. The primary objective of these excavations was an unusual bend in the creek at S-3 that could be

the result of recent fault movement, but a faultlike feature exposed during cutting of the access road to S-3 was also investigated (S-4). The results of this work are summarized as follows

1. The lower terrace deposits are well bedded, and any fault offset could be detected if present.
2. The lower terrace deposits at the sharp bend (actually a sharp doubling back) of the creek are not faulted at or above creek level. If this unusual feature is related to recent faulting, the relationship is not apparent.
3. The fault-like feature in the access cut is actually the south bank of a channel that was previously located just north of the existing creek alignment in this area. Shallow exposures (3-4 feet) suggested possible faulting, but deeper cutting exposed relationships indicative of erosion and deposition along the older channel alignment.
4. The older channel configuration is such that the lower terrace deposits are probably older than the upper terrace surfaces and deposits.

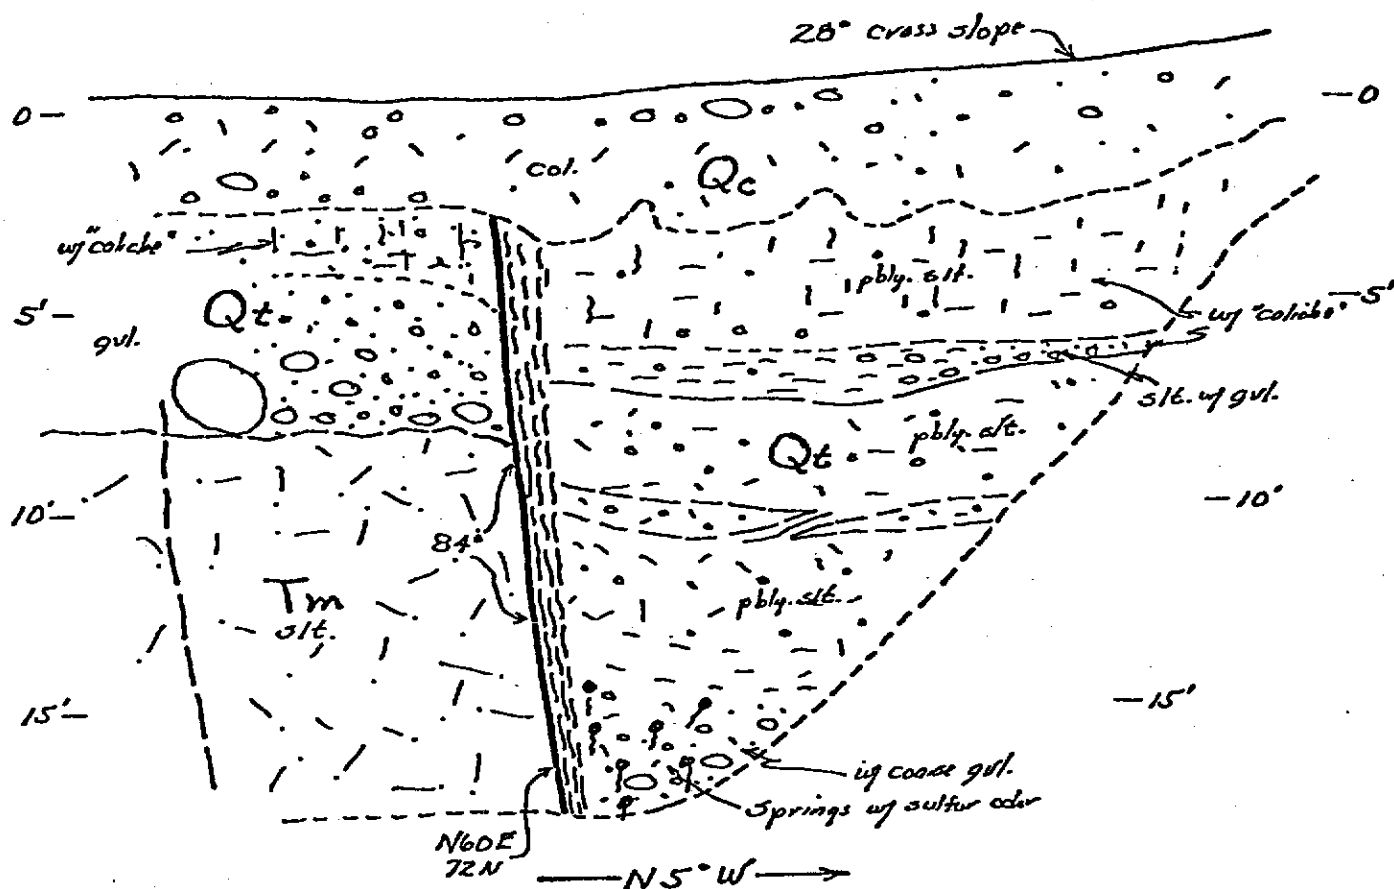
west side of the trench, at and near the fault plane, is included here as Figure 2. The principal conclusions from this exposure are as follows:

- a. The colluvium in the uppermost 32-42 inches of the trench wall shows no evidence of fault movement. However, this material is located on a relatively steep slope (28°) on which creep would be expected that would obliterate any evidence of recent faulting.

- b. The materials below the colluvium have been cut by numerous episodes of faulting along a zone of shearing approximately one foot wide. These include 5 feet of terrace gravel on the southeast side of the fault and at least 14 feet of terrace silt, clay and gravel on the northwest side of the fault.

- c. On the basis of their general appearance, these terrace materials are probably late Pleistocene in age, and may correlate with the marine terraces near the mouth of the Canyon. These terraces correlate generally with those near Goleta dated by the U.S. Geological Survey at about 40,000 years old.

- d. The terrace materials on either side of the fault are quite different, indicating that the fault movement is not a simple up-down relationship. The thicker, finer-grained, and darker nature of the terrace material on the northwest side of the fault suggest that it may have been moved laterally from a more central location in the old channel to its present position on the side of the canyon.

Figure 2. Log of west wall re-excavated trench in Alegria Canyon showing fault relationships between Monterey Shale (Tm), Quaternary terrace deposits (Qt) and colluvium (Qc).

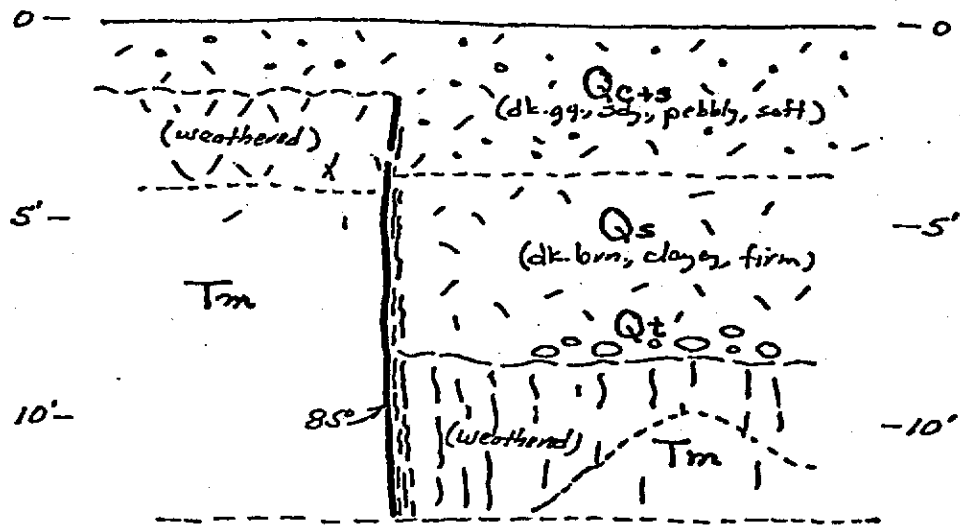
The trench on the west ridge shows clear indications of faulting of soil and/or colluvial deposits to within 22 inches of the surface (Figure 3). The upper $3\frac{1}{2}$ to 4 feet of soil, of which about 2 feet is in fault contact with bedrock, is softer and coarser grained than the lower $4\frac{1}{2}$ to 5 feet of soil on the northwest side of the fault. Based on appearance and character of the materials, Dr. Shlemon concluded that a remnant of a soil horizon is present at a depth of two to three feet that is probably older than 10,000 years, but probably younger than 20-30,000 years. This soil is in fault contact with bedrock along the fault zone. The younger material above this soil is colluvium that is undergoing creep that would be expected to obliterate all but the most recent movements.

Figure 3. Log of southwest wall trench on ridge west of Alegria Canyon showing fault relationships between Monterey Shale (Tm), Quaternary terrace deposits (Qt) with overlying clayey soil (Qs), and younger soil and colluvium above (Qc + s).
